Sample Site Inspection Report

Project: System Inspection	
Location: Logan, Utah	
Client Name: Landscape Company	
10/2/2012 3:45:53 PM	Revision: 3
Created by: Jim	Approved by: Jim
Disclaimer:	
11 x 17	1/3

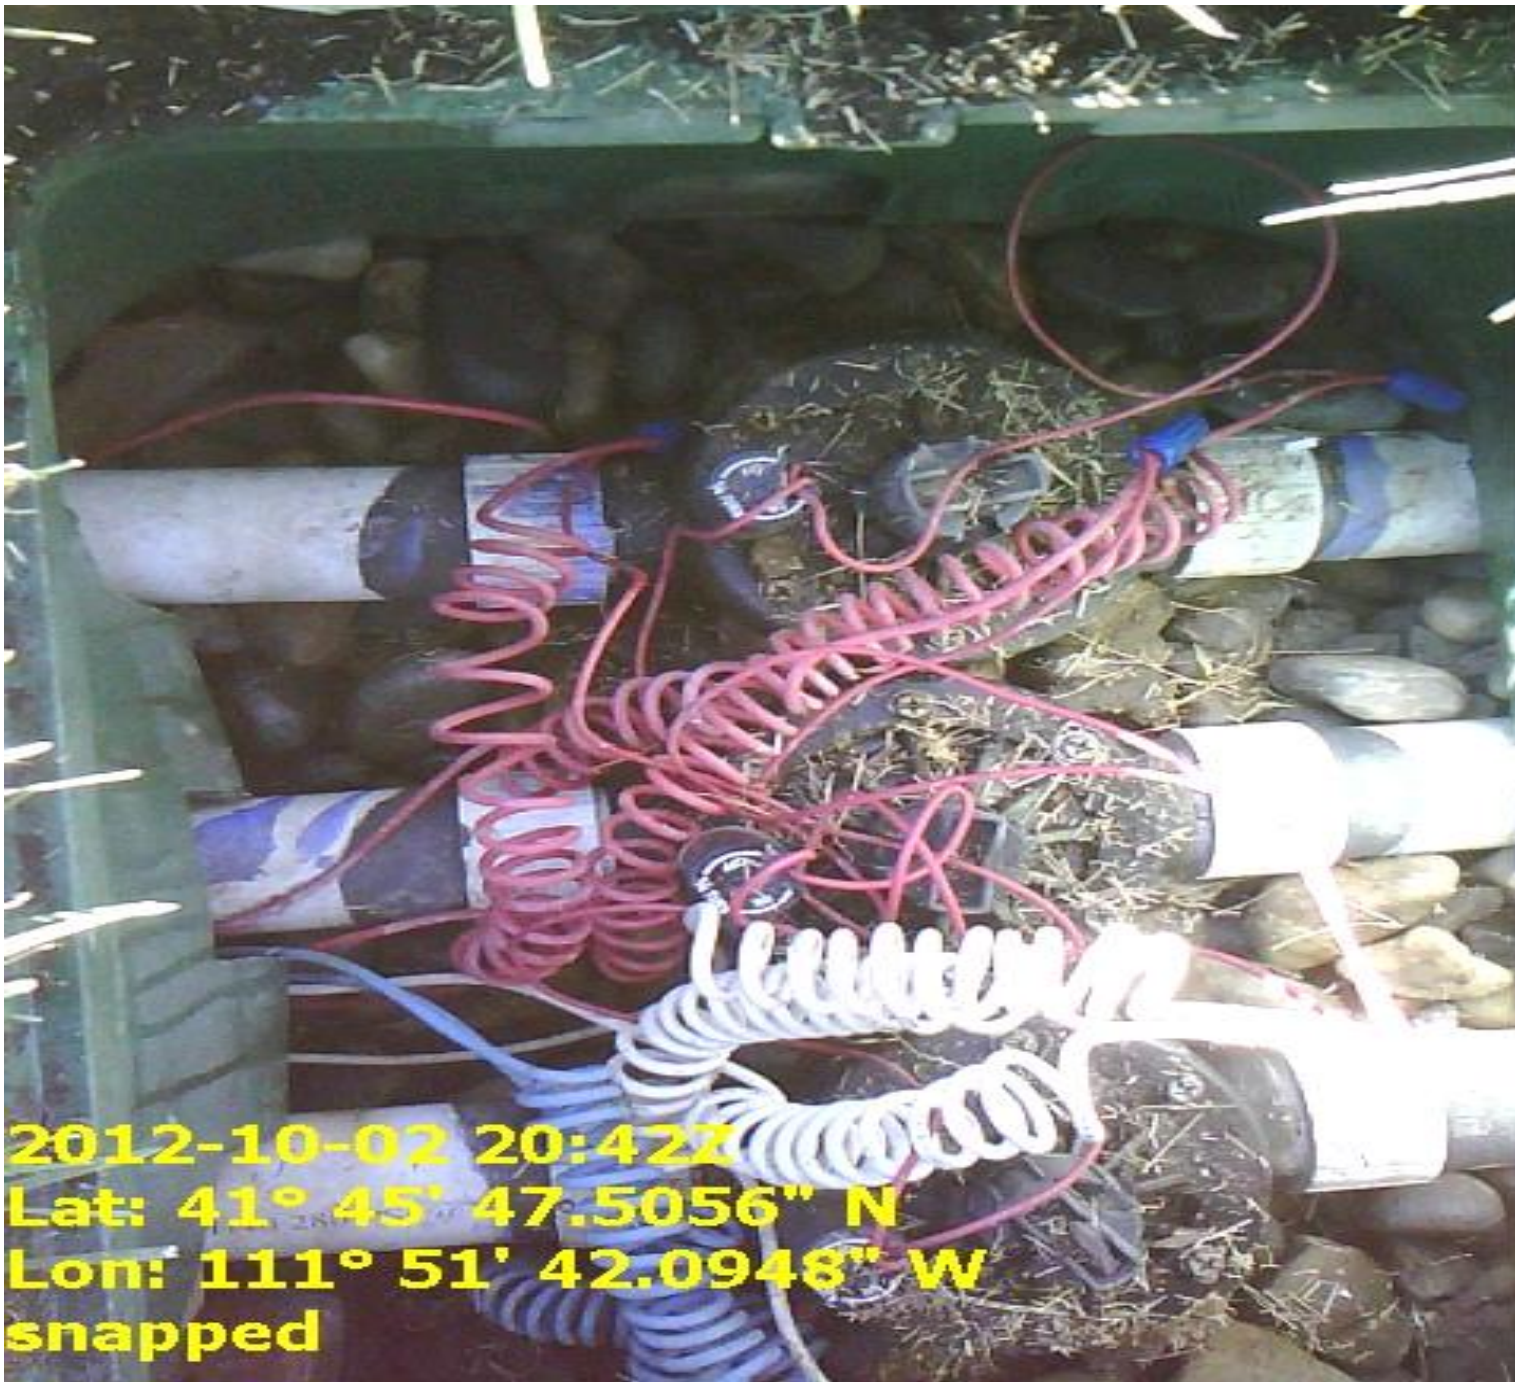
Leaking Control Valve

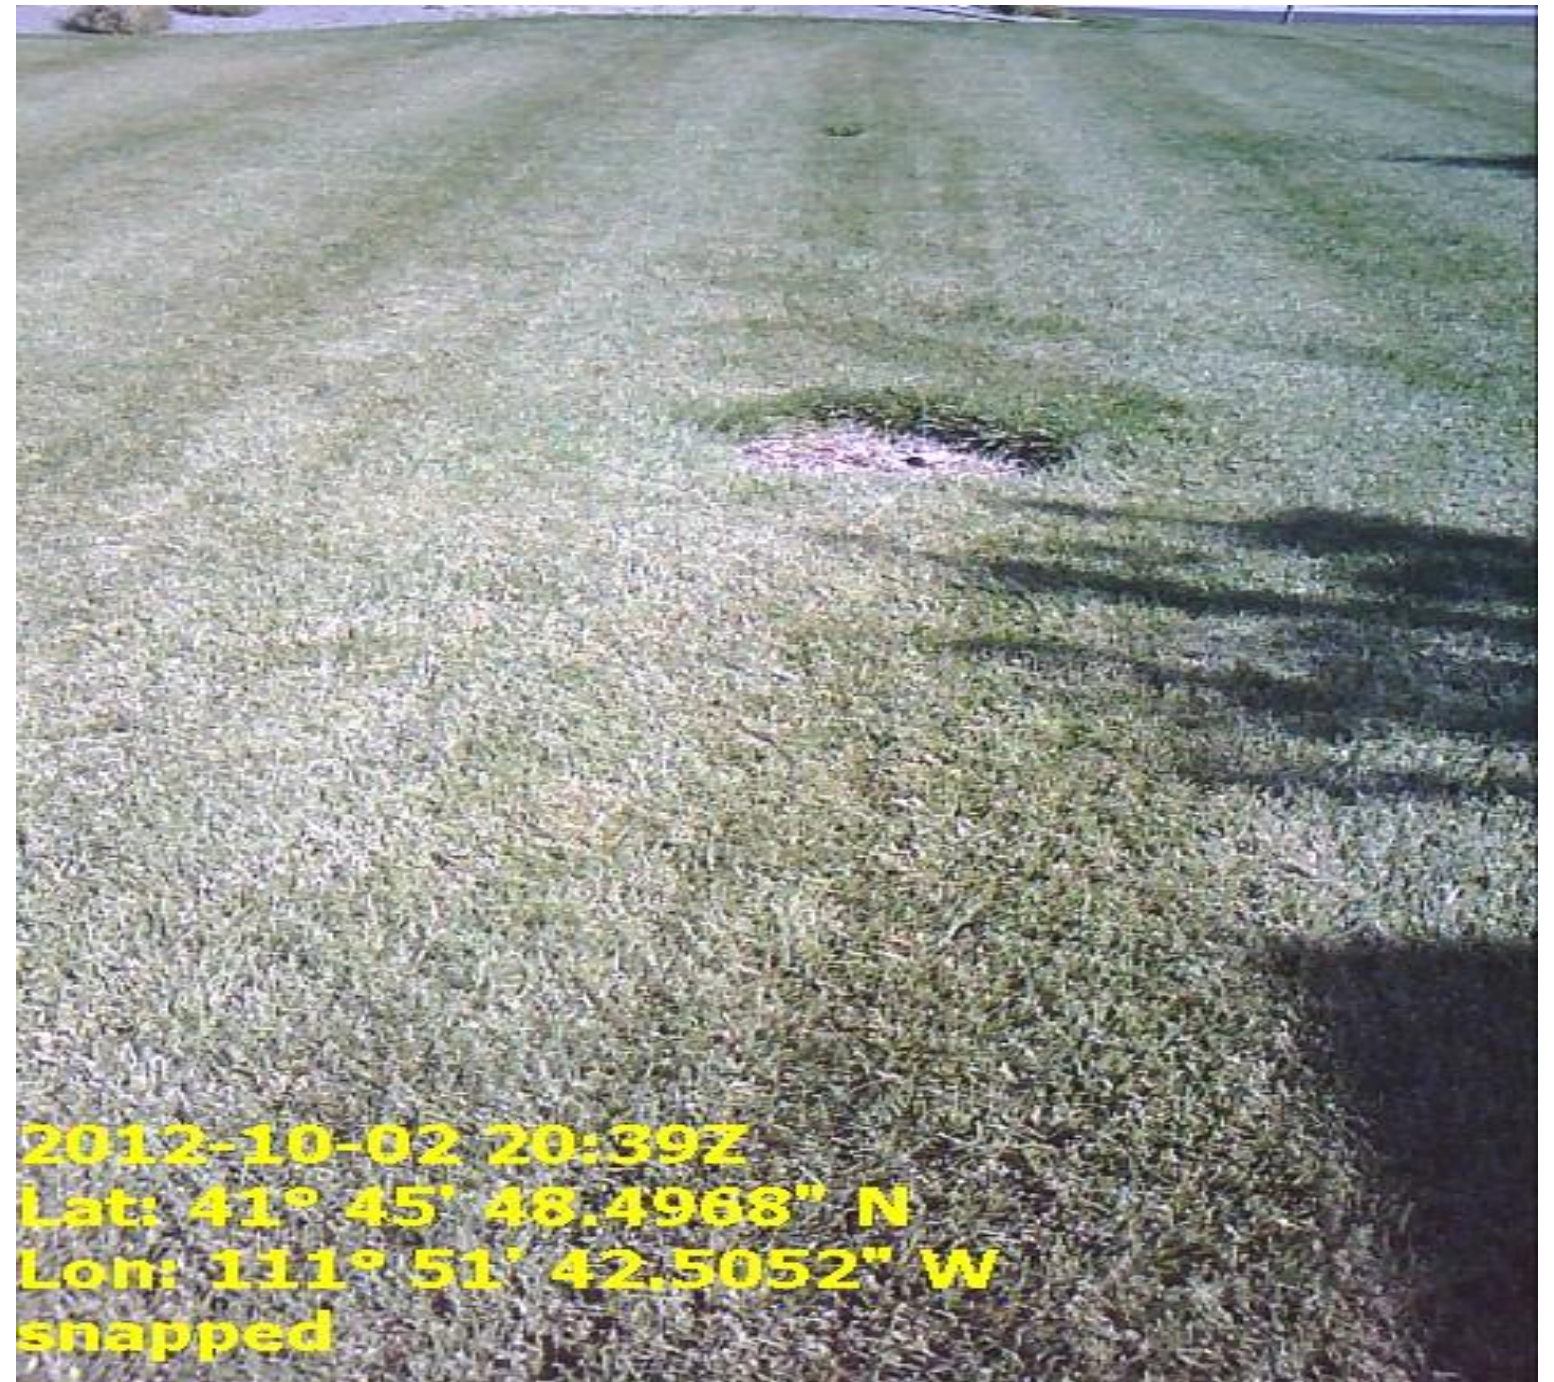
Dry Turf Area
